**REMOVAL PROGRAM
PRELIMINARY ASSESSMENT/
SITE INVESTIGATION REPORT
FOR THE
BATES MILL SITE
LEWISTON, MAINE
10 TO 11 MARCH 1998**

U.S. Environmental Protection Agency
Region I
Emergency Planning and Response Branch
John F. Kennedy Federal Building
Boston, MA 02203

Roy F. Weston, Inc.
Superfund Technical Assessment and Response Team
217 Middlesex Turnpike
Burlington, MA 01803

April 1998

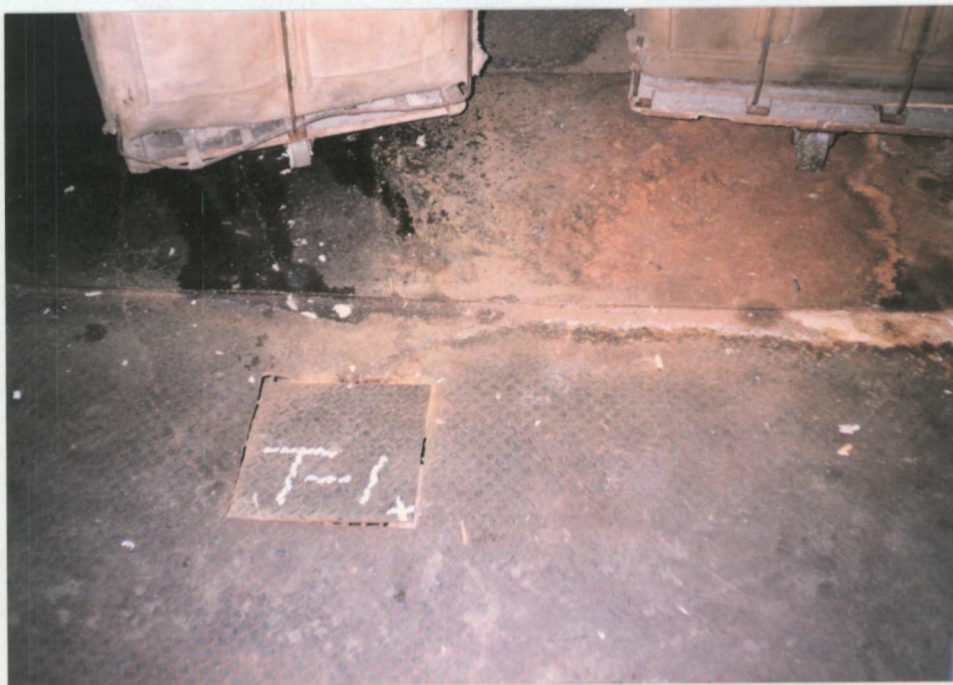
SCENE: View of sample station T-1. Access hatch cover to 20,000 gallon (approximate) “railroad” tanker car. View is from first floor of the Mill No. 4/Bleachery.

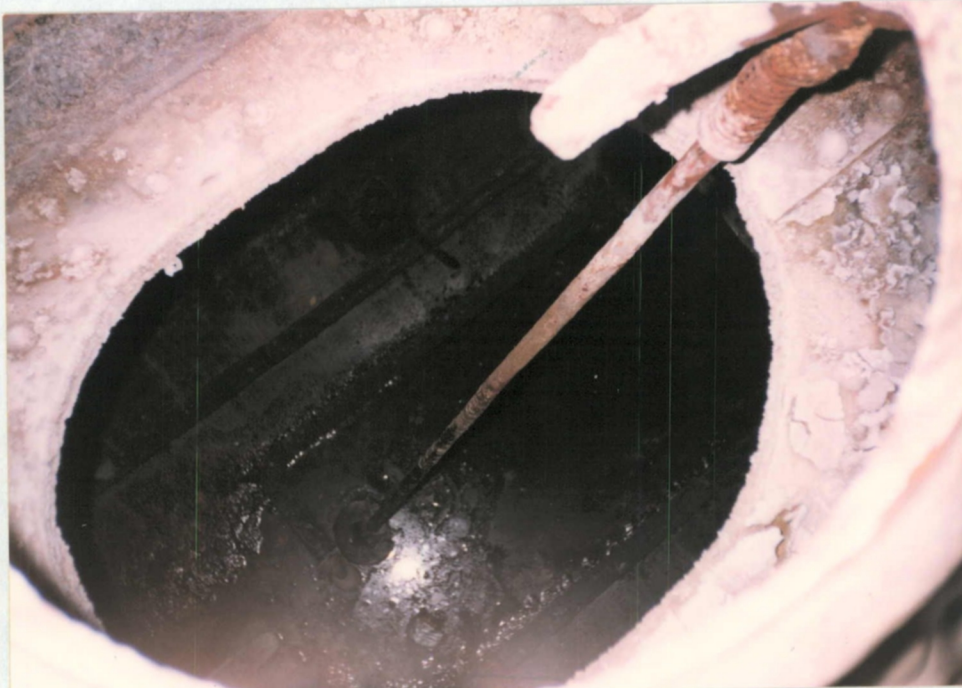
SCENE: View of sample station T-2, opening to the access hatch cover of "railroad" tanker car No. 2, an approximate 20,000 gallon AST (view through floor of Mill No. 4/Bleachery), westernmost of two "railroad" tanker cars.

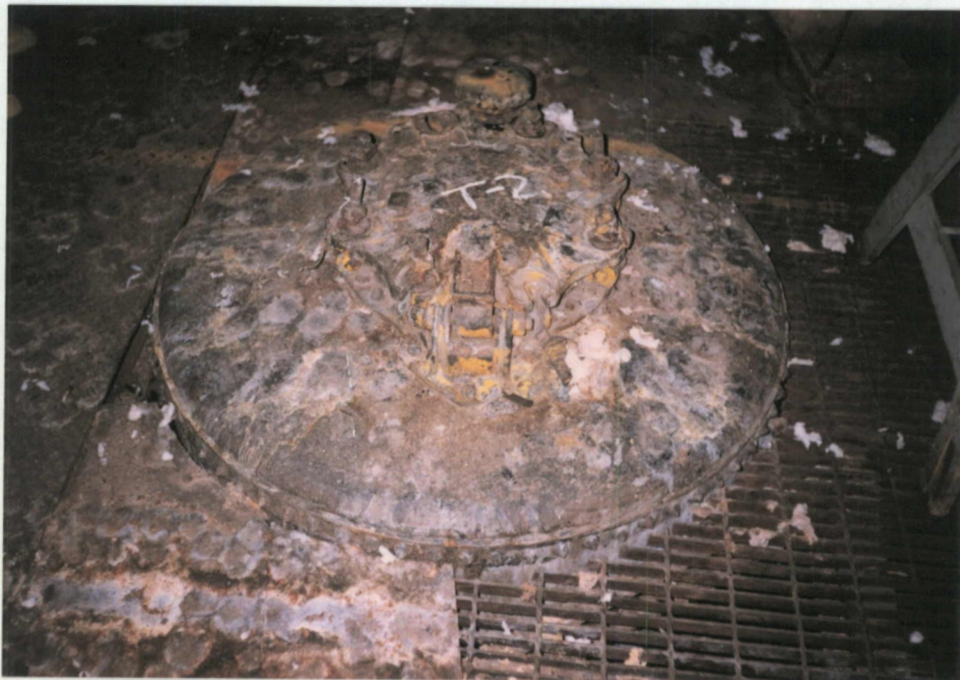
SCENE: View of sample station T-2. Access hatch cover to 20,000 gallon (approximate) "railroad" tanker car. View is from first floor of the Mill No. 4/Bleachery.

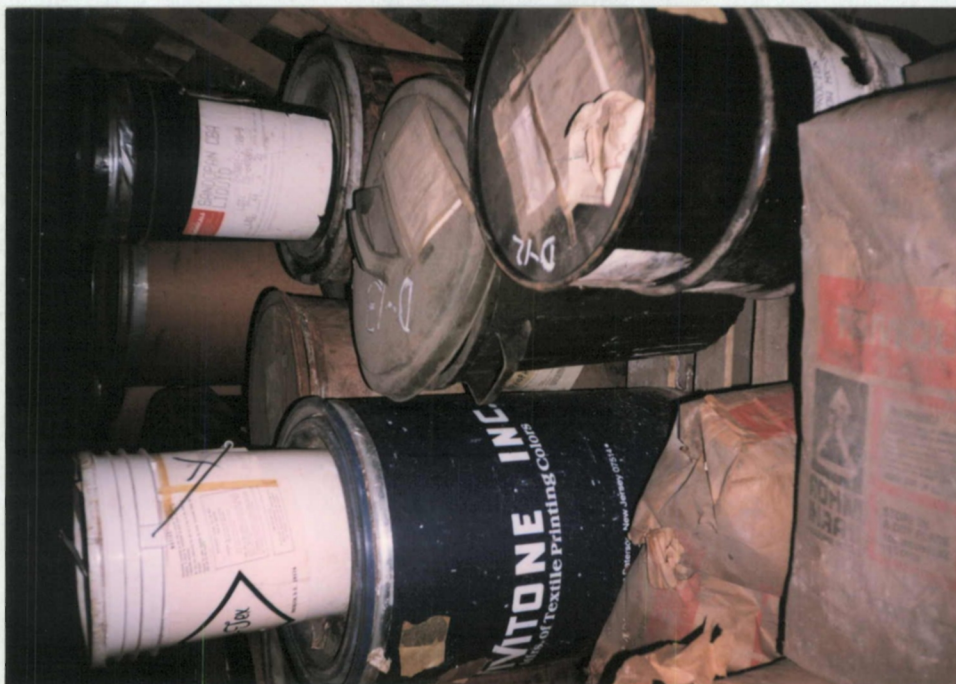
SCENE: View of sample stations D-12 and D-13. View of miscellaneous drums and bags of dry solid powders located in storage room in the northeast corner of the first floor of No. 1 Storehouse. View through a large swing door, looking north.

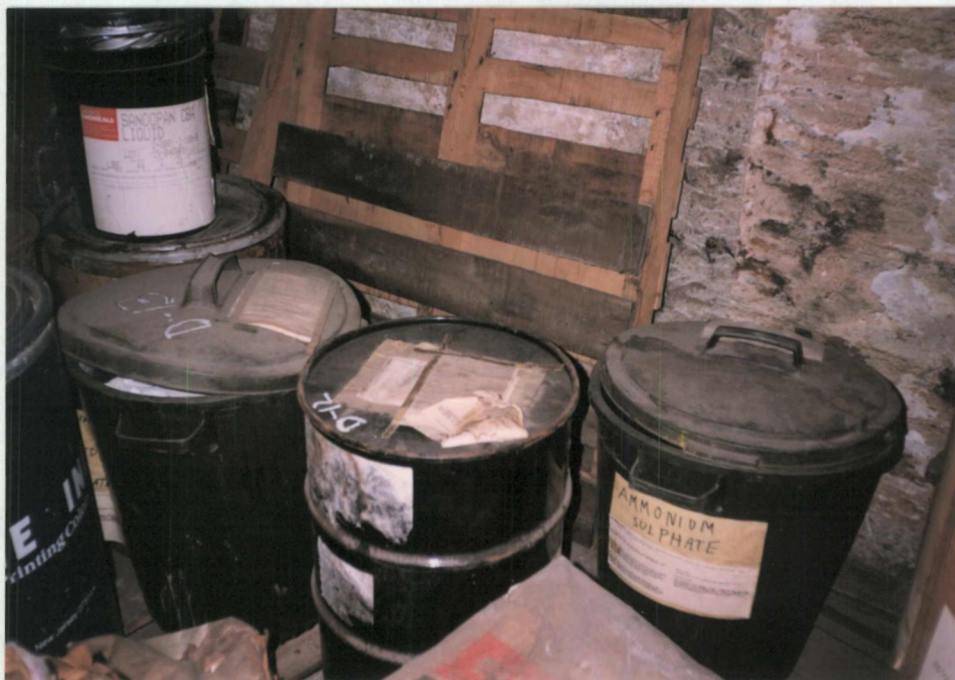
SCENE: View of sample stations D-12 and D-13. View of miscellaneous drums and containers along the east wall of the storage room located at the northeast corner of first floor of No.1 Storehouse (looking east). One drum labeled as ammonium sulfate.

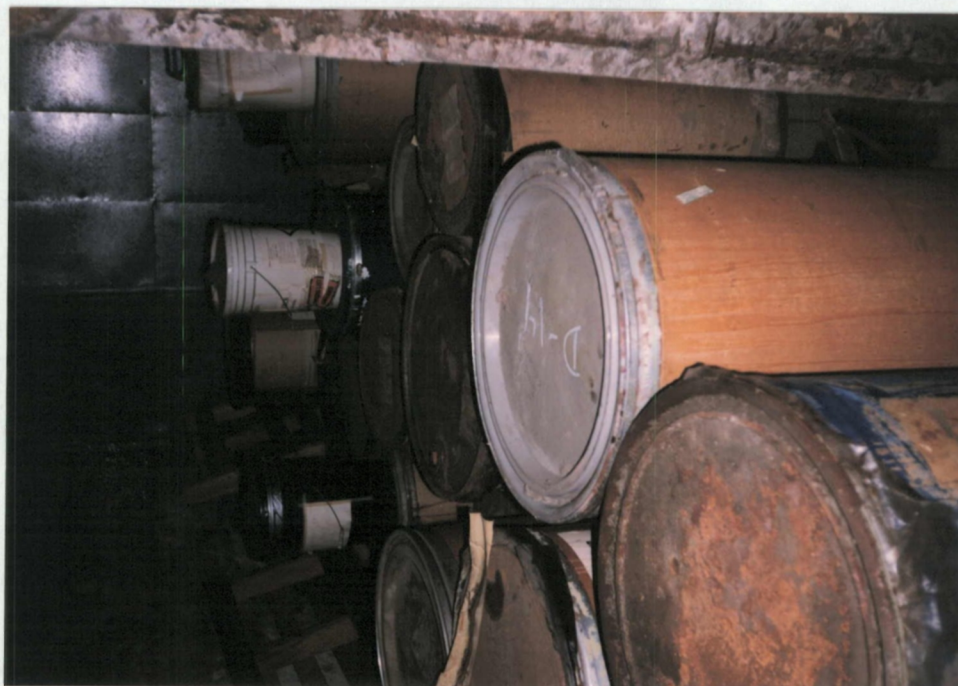
SCENE: View of sample station D-14. View of miscellaneous fiber drums located in the storage room at the northeast corner of the first floor of No.1 Storehouse (looking south).
